NCSC under MoD
Research and Development division
support@ims.nksc.lt

REPORT ON THE ASSESSMENT OF CYBER SECURITY OF VIDEO SURVEILLANCE CAMERAS INTENDED FOR HOUSEHOLD USE

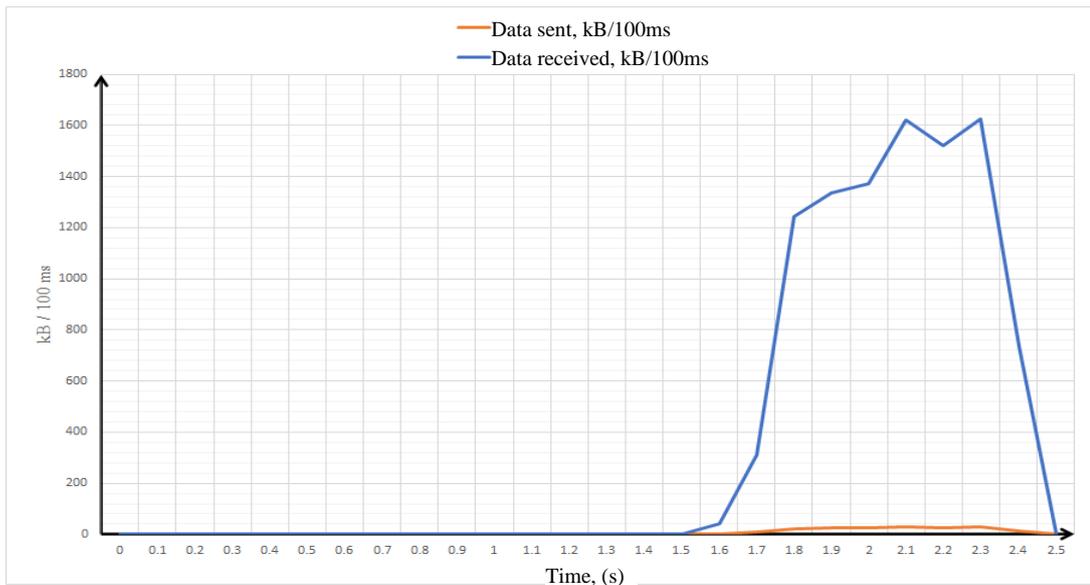
Network monitoring tests did not reveal any standalone requests of the Hikvision camera to remote servers. After the user initiated the plugin download in the administration panel (works with older browsers – IE10, etc.), the camera contacted the German IP address 49.51.129.XXX registered in Germany and downloaded it. The plugin address was identified: <http://hikdownload.hik-connect.com/web/webplugin/windows/local-service-components/v1.0.0.0/standard/LocalServiceComponents.exe?timeStamp=1597683420253>. The graph of the network traffic generated by the camera during the download is shown in Figure 1.

Fig. 1 Hikvision camera network traffic after plugin download initiation

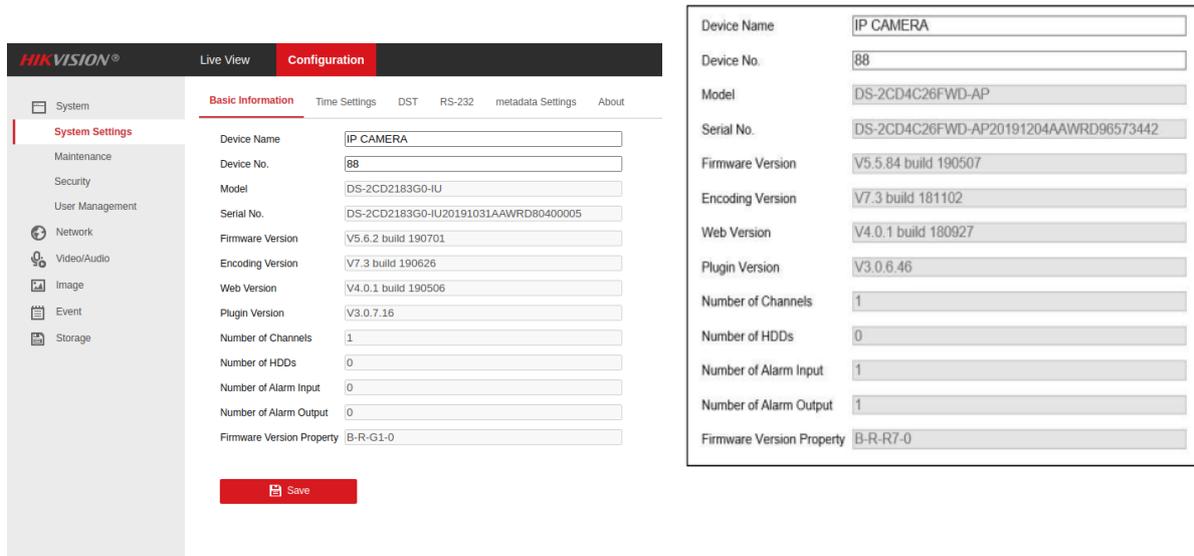
The observed close similarity of the graphical interface of the Hikvision cameras possibly indicates that the manufacturer uses similar or the same technological solutions in different devices. A comparison of the graphical interface of the Hikvision cameras is shown in Figure 2.

Fig. 2. Comparison of Hikvision camera control panels

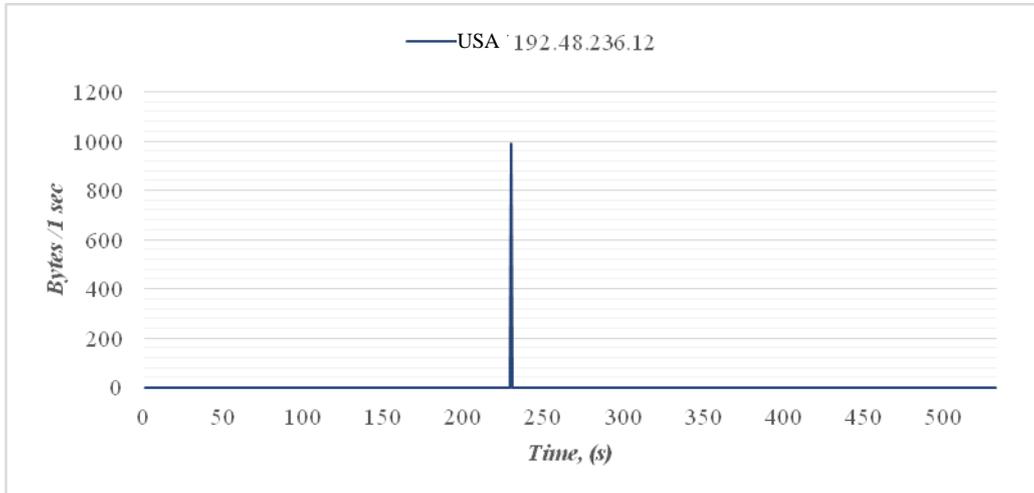
Fig. 3. Two-way TLSv1.2 communication between the mobile device and the USA server (192.48.236.XXX)

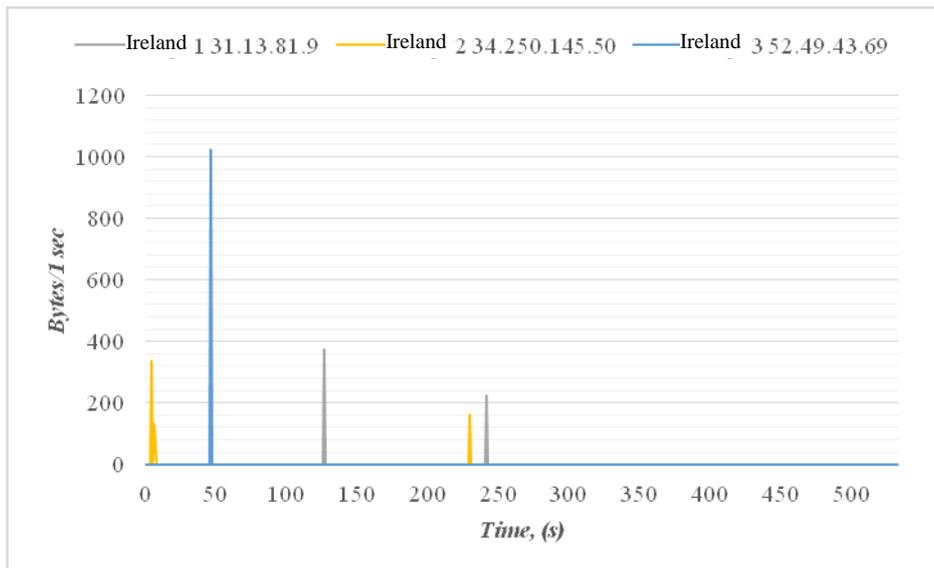
Fig. 4. Two-way TLSv1.2 communication between the mobile device and the servers Ireland 1, Ireland 2 and Ireland 3

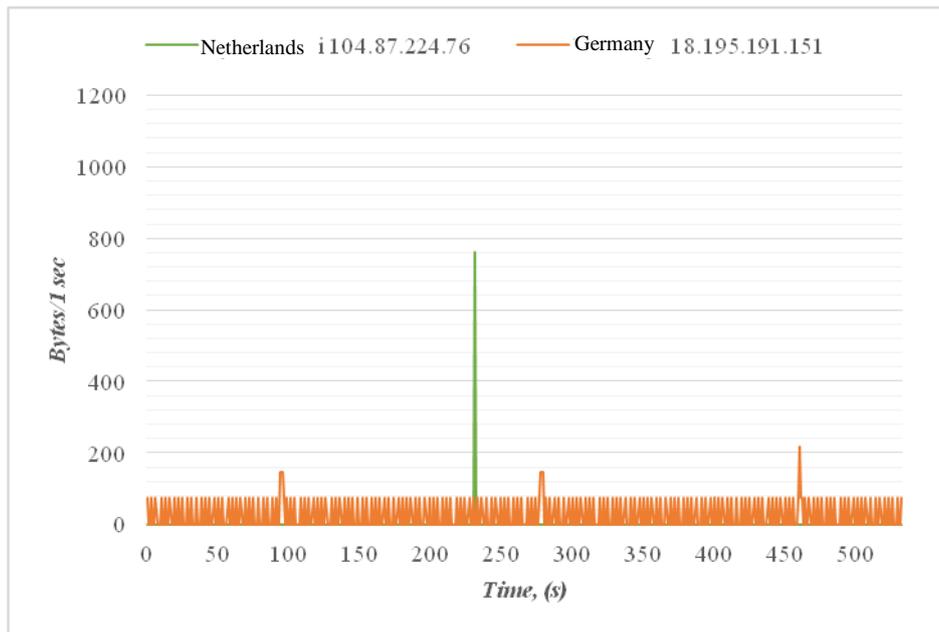
Fig. 5. Two-way communication via TLSv1.2 protocol between the mobile device and the Netherlands server; the UDP protocol requests sent from the mobile device to the Germany server (34.250.145.50).

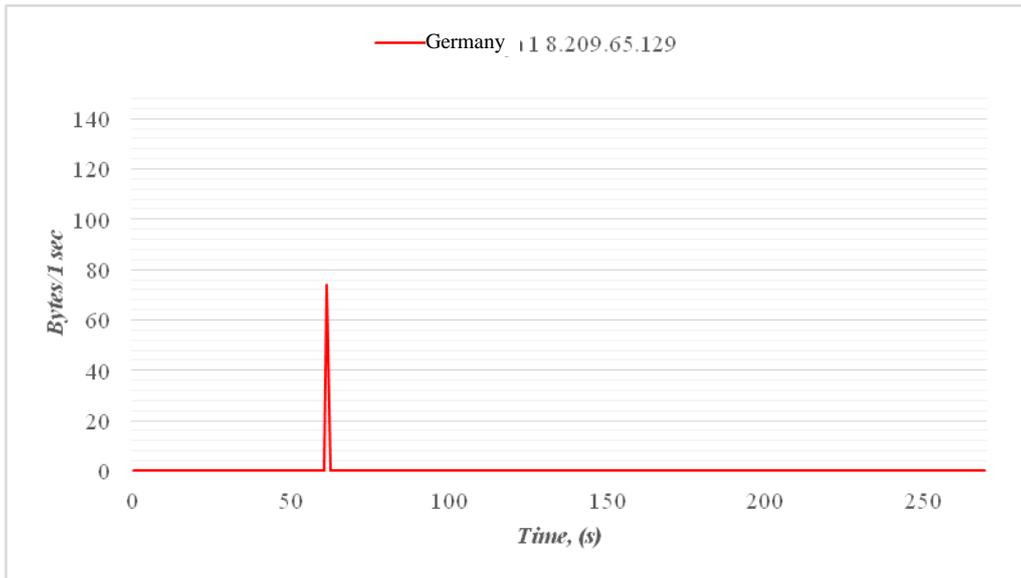
Fig. 6. One TCP package from the mobile device to the server Germany 1 (8.209.65.129)

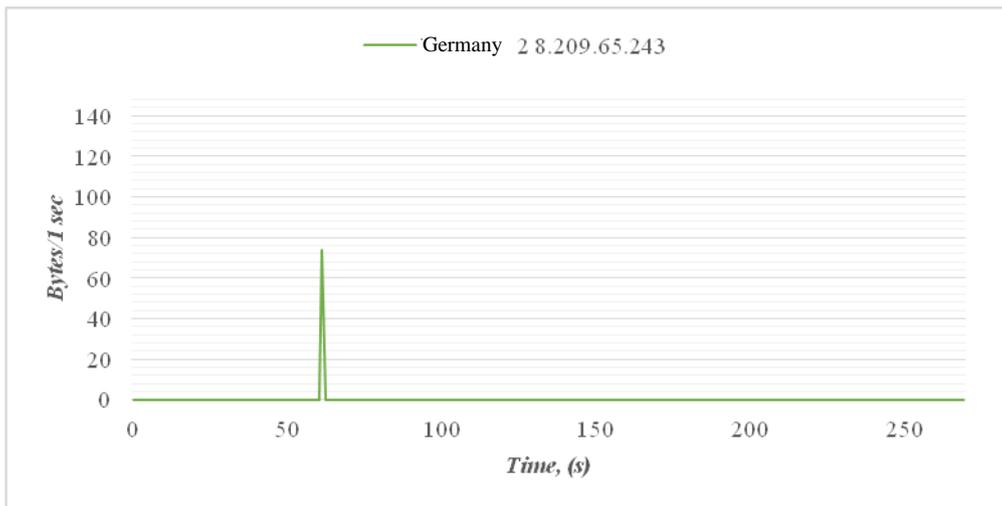
Fig. 7. One TCP package from the mobile device to the server Germany 2 (8.209.65.243)

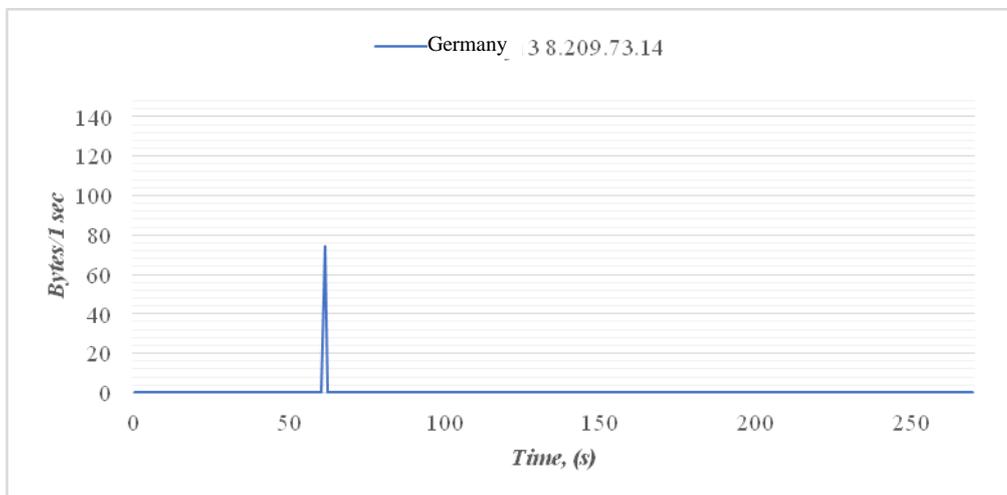
Fig. 8. One TCP package from the mobile device to the server Germany 3 (8.209.73.14)

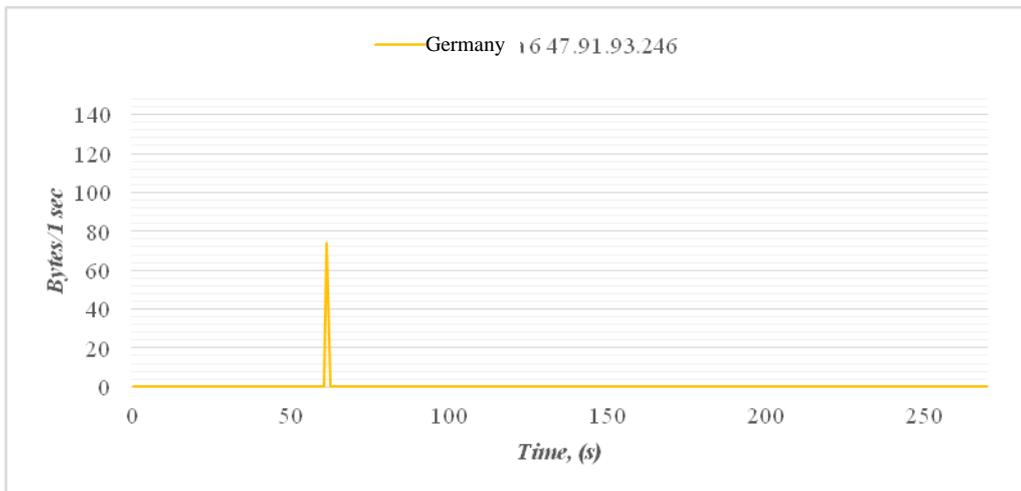
Fig. 9. One TCP package from the mobile device to the server Germany 6 (47.91.93.246)

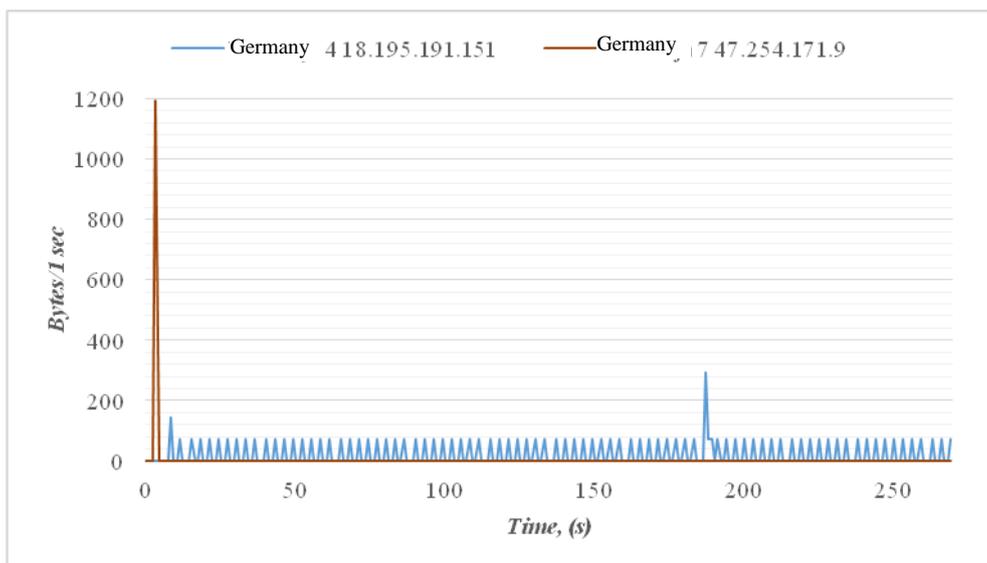
Fig. 10. Continuous sending of device’s HTTP requests via UDP protocol to the server Germany 4 (18.195.191.151) and one HTTP request via UDP protocol to the server Germany 7 (47.254.171.9)

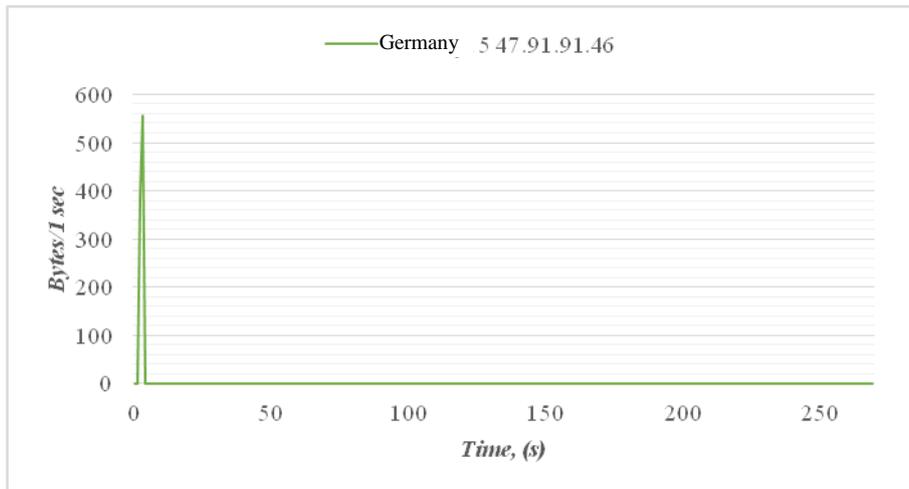
Fig. 11. Two-way UDP communication between the mobile device and the server Germany 5 (47.91.91.46)

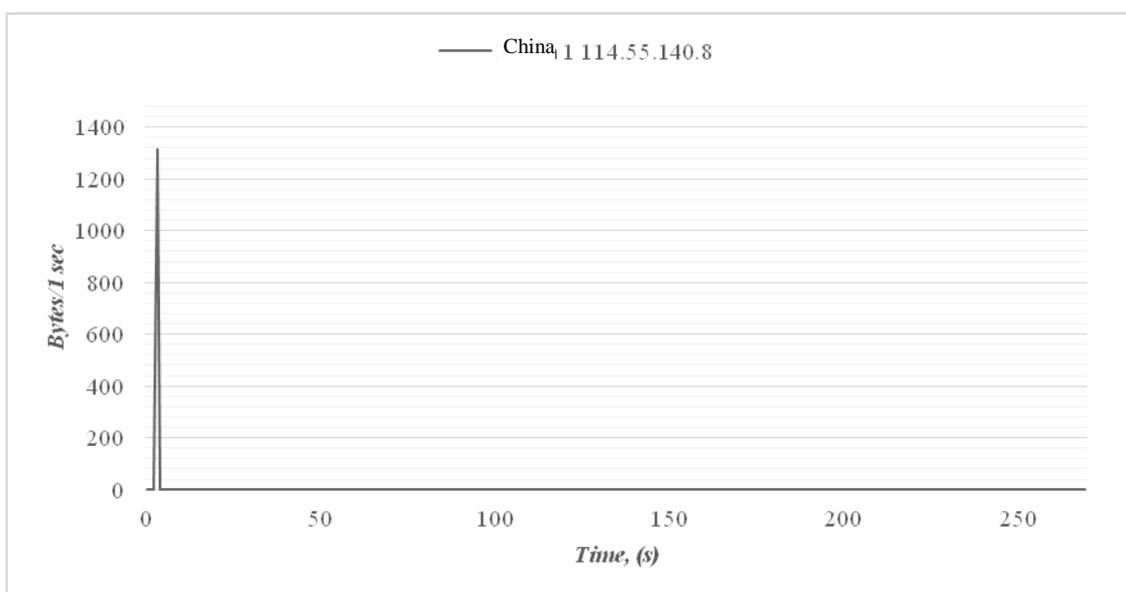
Fig. 12. Two-way UDP communication between the mobile device and the server China 1

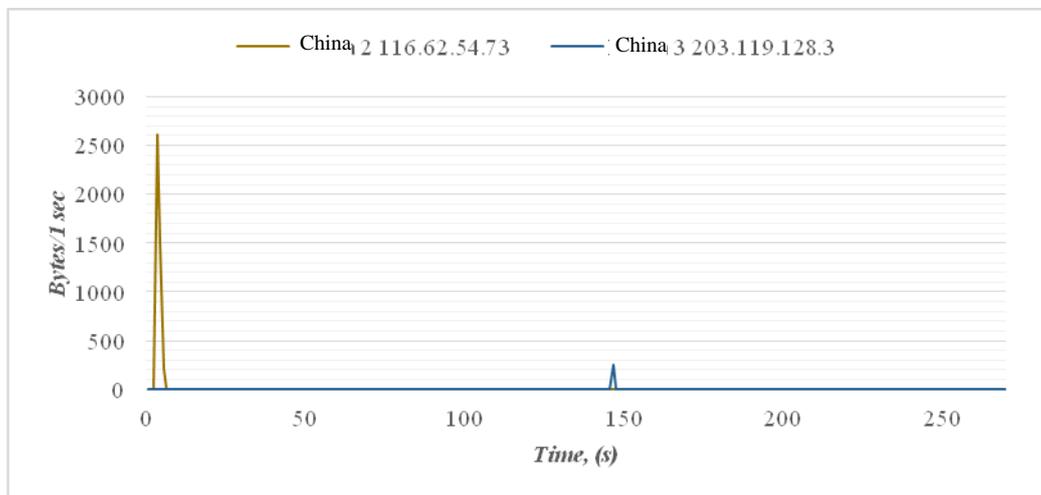
Fig. 13. Two-way UDP communication between the mobile device and the server China 2

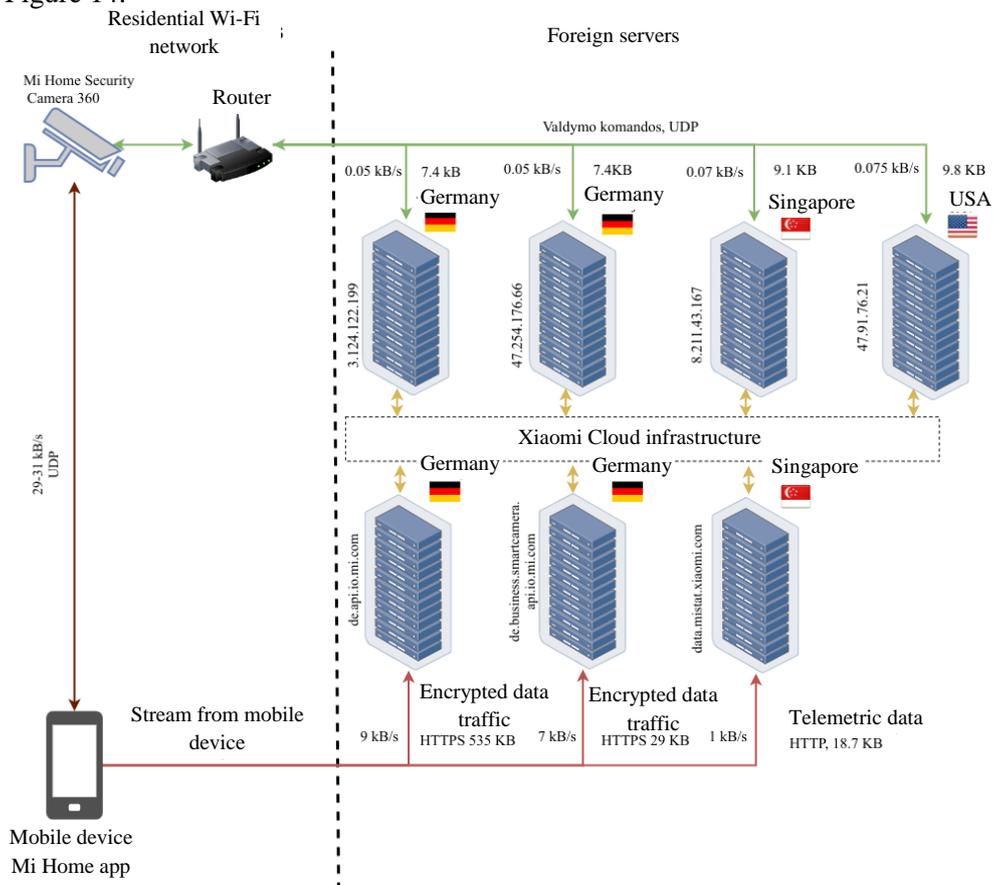
The mobile application sends control requests to servers in Germany (2) and Singapore (1), which transform them into camera control requests via the cloud platform and forward them through the secondary servers in Germany (2), Singapore and the USA. An associative operation diagram of the system when the controlling mobile application and the camera are connected to the local network is shown in Figure 14.

Fig. 14. Associative diagram of Xiaomi camera operation, when the camera and the mobile application that controls it are connected to a local network

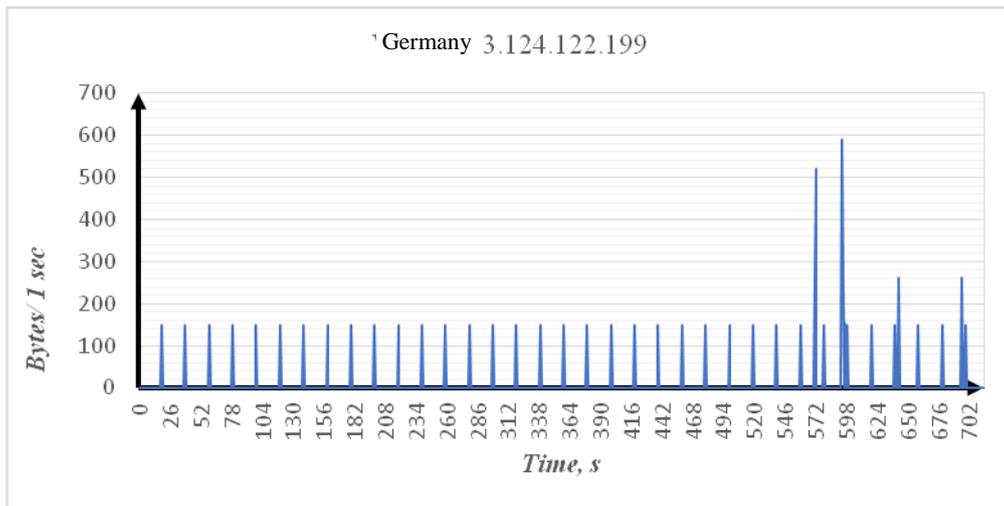
Fig. 15. Xiaomi periodic server requests to the server 3.124.122.199 (Germany)

The graphs show a well-expressed periodic characteristic of the camera's access to remote servers. Constant communication with remote infrastructure servers can potentially increase security risks; requests to servers are not controlled, they are sent periodically, and camera control commands received from the servers are not verified by the camera administrator (user).

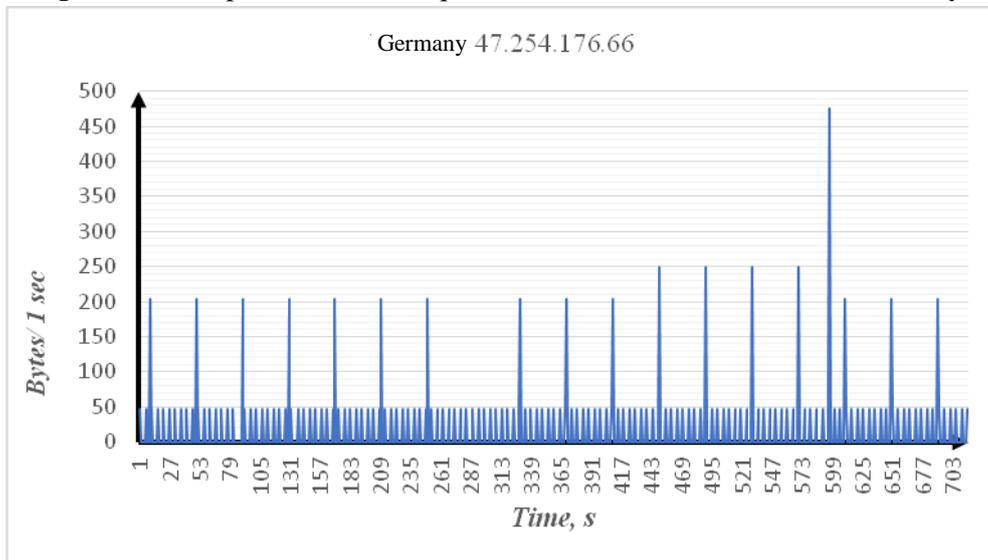
Fig. 16. Xiaomi periodic server requests to the server 47.254.176.66 (Germany)

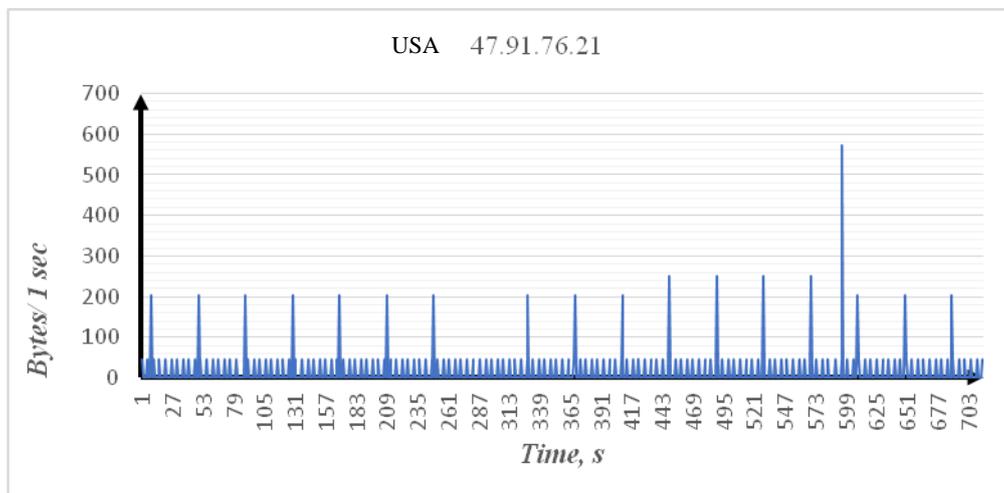
Fig. 17. Xiaomi periodic server requests to the server 47.91.76.21 (USA)

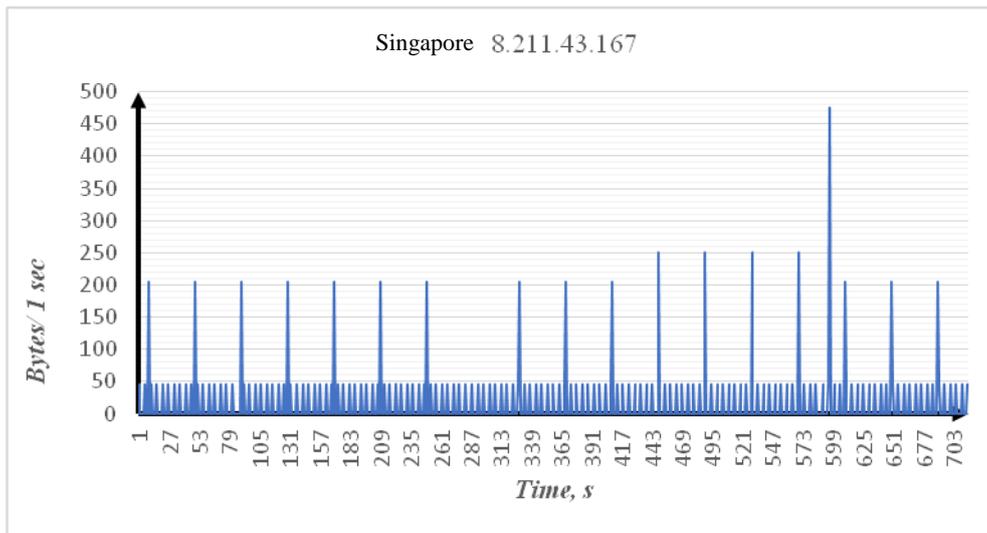
Fig. 18. Xiaomi periodic server requests to the server 8.211.43.167 (Singapore)

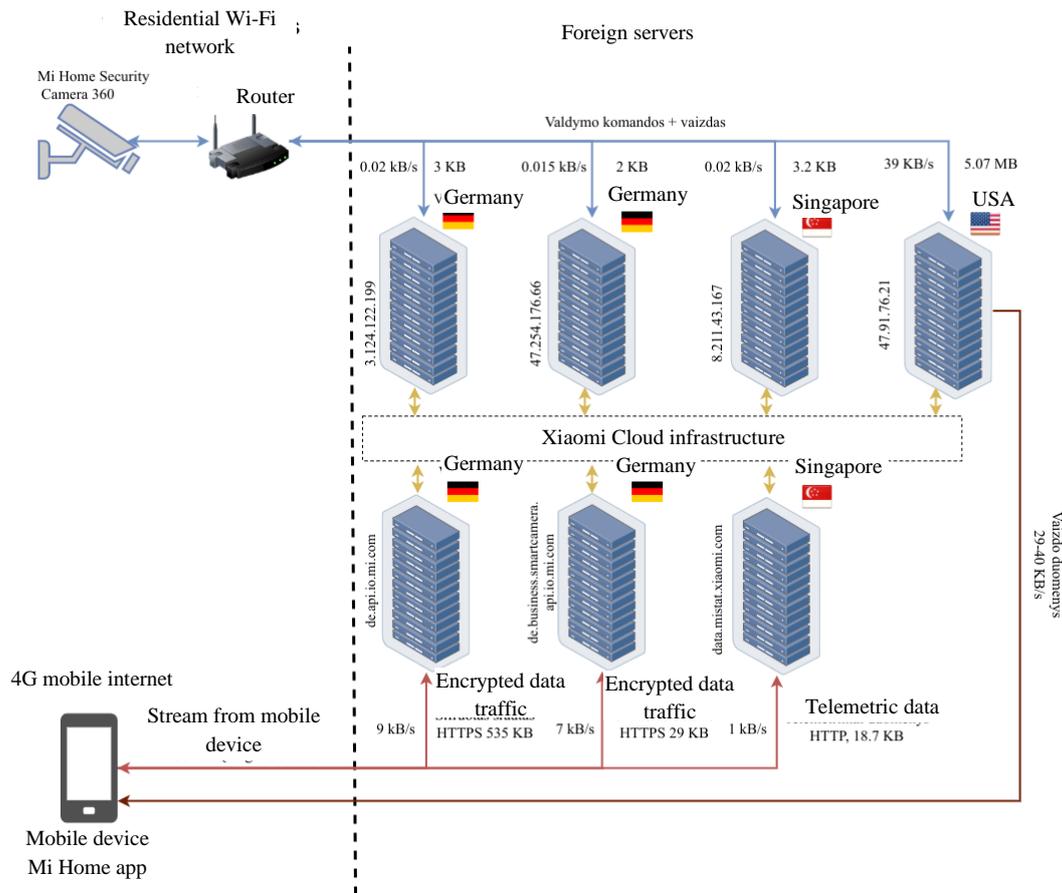
The camera having no direct connection to the mobile application, all data exchange (including camera-generated audiovisual content) is performed using Xiaomi cloud infrastructure. A diagram of this case is presented in Figure 19.

Fig. 19. The camera and the control application are not connected through the local network

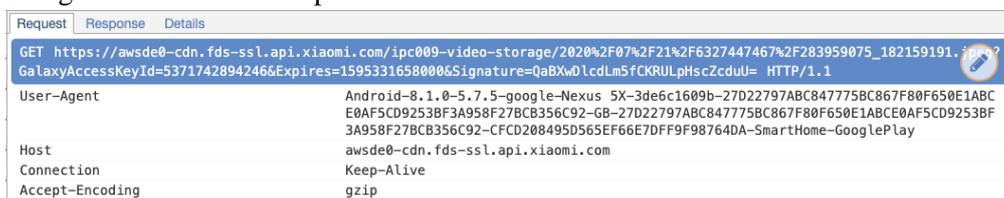
Fig. 20. Request to download recorded images or videos from the camera

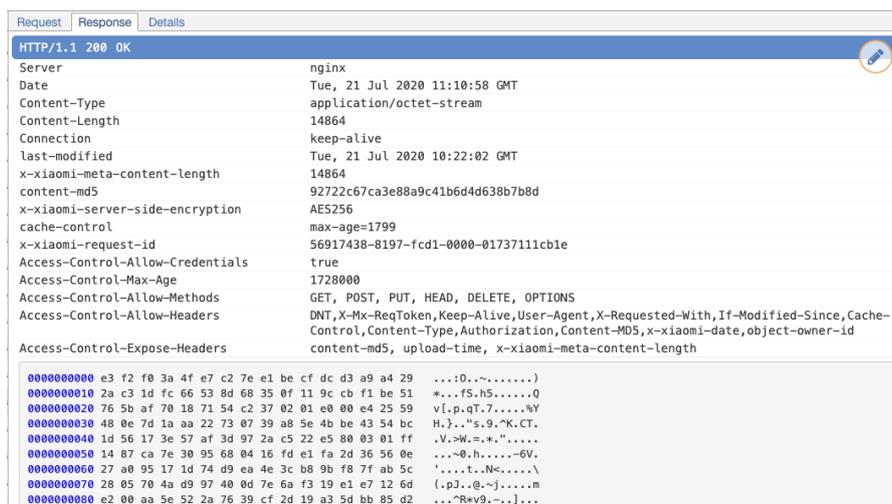
Fig. 21. The response provided by the Xiaomi server

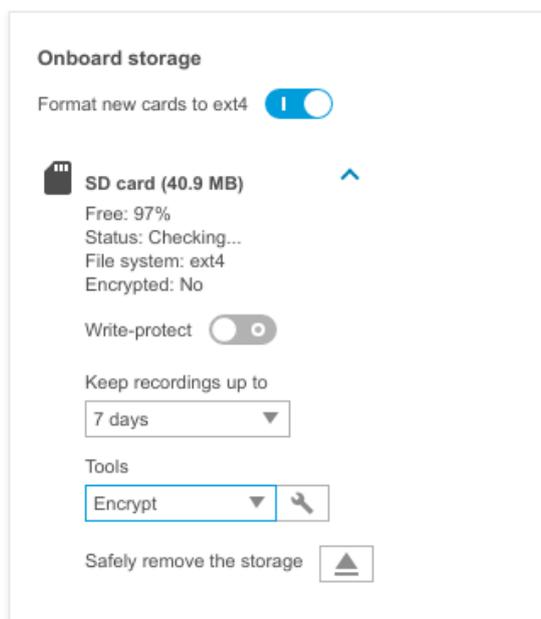
Fig. 22. Graphical image of the SD card encryption interface

The AES-128 used for encryption ensures a high level of data security and is enabled by the resources of the processor used.
